Manhole Inspection Summary

Manhole # S35II1011MH

Insp Date: **8/13/08 2:16 PM**

Location Address: **224 WENDOVER**

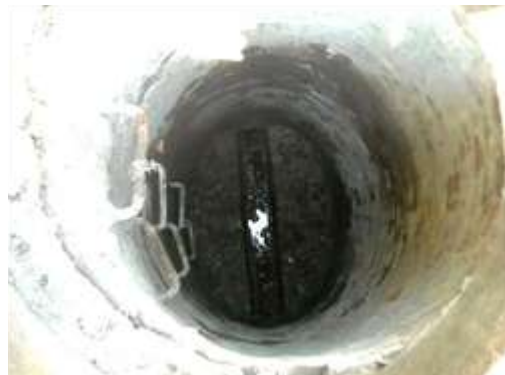
Top View

Corbel and Barrel infiltration. Evidence of surcharge - Bench debris. Channel debris.

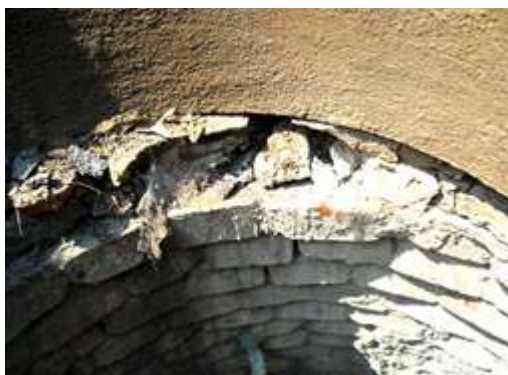
Defect

Frame Offset: **1.5** (in.) Condition: ☐ Sound ☐ Cracked ☒ **Leaks**

Chimney / Frame Adjustment ☒ Exists Material: **Brick** ☐ Parged Height: **3** (in.)
Condition: ☐ Sound ☐ Cracked ☐ Root Intrusion ☒ **Loose Brick** ☒ **Deteriorated**
Infiltration: ☐ None ☒ **Joint** ☐ Cracks ☐ Mortar ☐ Roots ☐ Wall

Frame leaks. Frame offset. Adjustment deterioration, loose brick and infiltration.

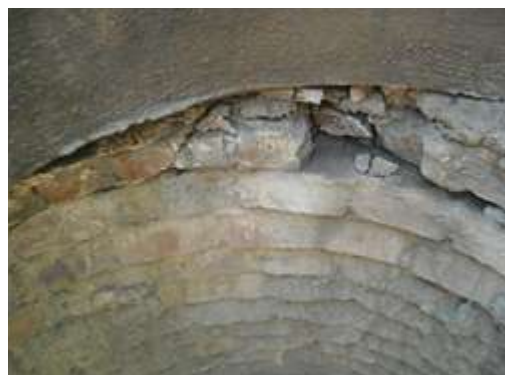
Defect

Frame leaks. Frame offset. Adjustment deterioration, loose brick and infiltration.

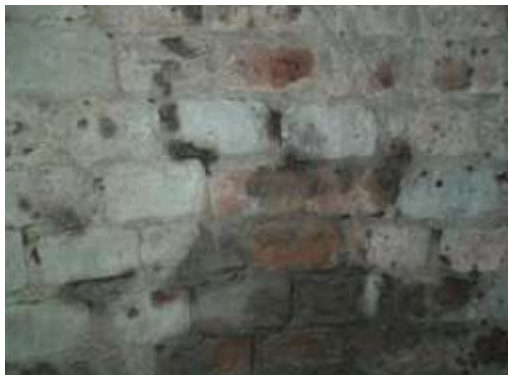
Defect

Barrel infiltration.

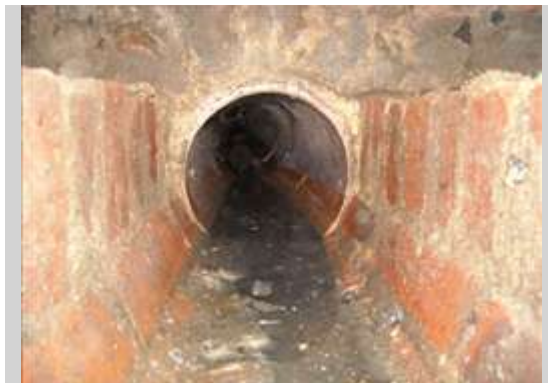
Pipe Out @ 12 O'Clock

Deposits: ☐ None ☒ **Mud** ☐ Sludge ☒ **Debris** ☐ Grease

Silt Depth: **0.5** (in.) Deposits Extent: **Light**
